# Pressurizer Nozzle WOL

## Addressing Primary Water Stress Corrosion Cracking (PWSCC)

### Alloy 600 Pressurizer Nozzle Mitigation – Almaraz Units 1 & 2

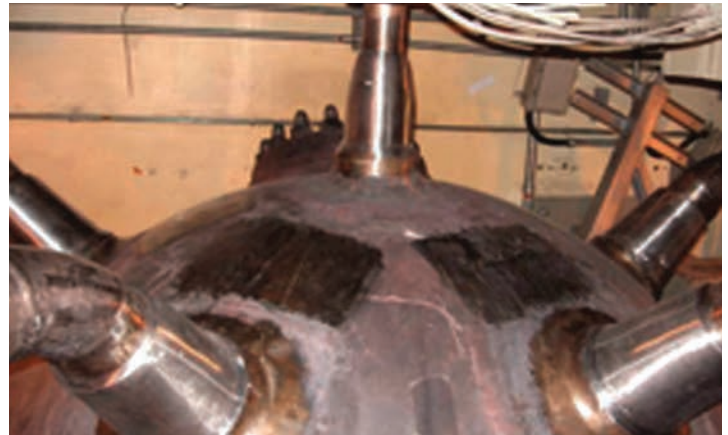
Primary water stress corrosion cracking (PWSCC) continues to be a concern in nickel-based alloys (Alloy 600 and the associated weld metals, Alloys 82 and 182) in both Boiling Water (BWR) and Pressurized Water reactors (PWRs). It has caused cracking and leakage in a number of components, including steam generator tubes, vessel penetrations, and most recently, the dissimilar metal butt welds (DMWs) commonly used to connect vessel nozzles to PWR primary system piping.

The most practical method found to date to mitigate these issues is to apply a structural overlay using Alloy 52M. Weld overlays have been used extensively in the past to repair nuclear plant piping that has been found to be cracked or leaking due to stress corrosion cracking. WSI has been at the forefront of this mitigation approach in the global nuclear markets.

WSI successfully provided project planning and Weld Overlay (WOL) repairs for Alloy 600 Pressurizer locations at the Almaraz 1 & 2 units in Spain. The WOL repair tasks were performed with proprietary remote-operated automated technology: included training, equipment, filler material, welding, and requisite surface preparation. Repair design and licensing support were provided by Structural Integrity. Project planning and support were provided in partnership with Iberdrola Engineering.
